FINAL DESIGN REPORT / ENVIRONMENTAL IMPACT STATEMENT

Appendix L – Bridge Information

Highway Project
P.I.N. 1721.51
BINs: 1033141 / 1033142
Interstate 87 (I-87) Exit 4 Access
Improvements
Albany County

BIN 1033141

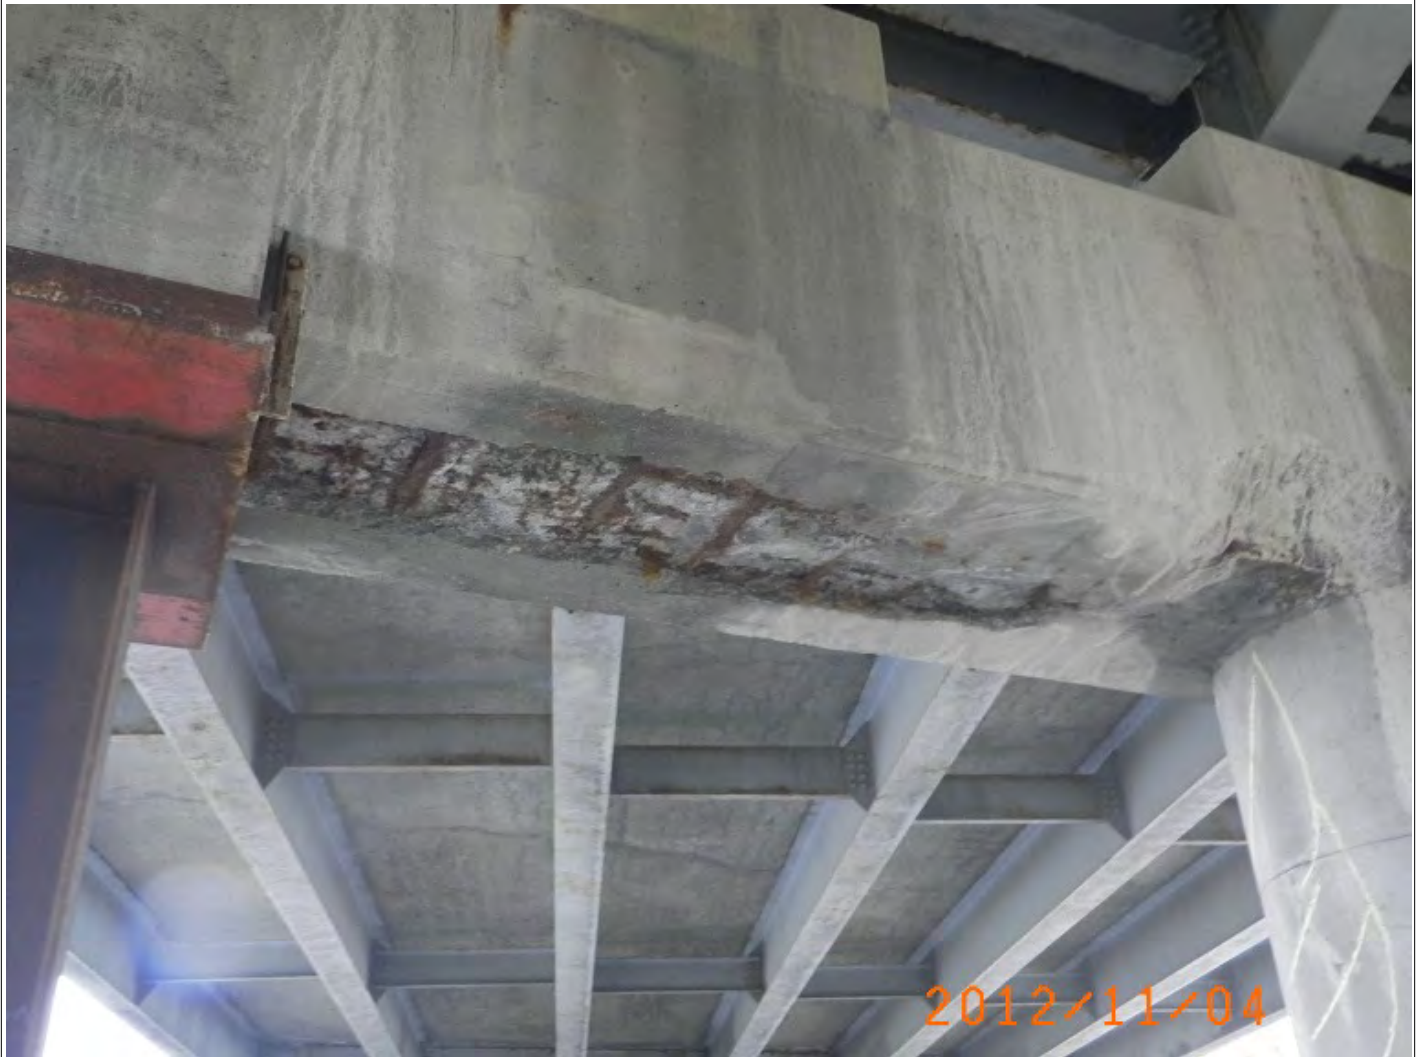
12-2869.JPG - Attached to Yellow Flag 1P120028

Underside of cap - Begin face - between the Bay 1 temp steel column and Column 2

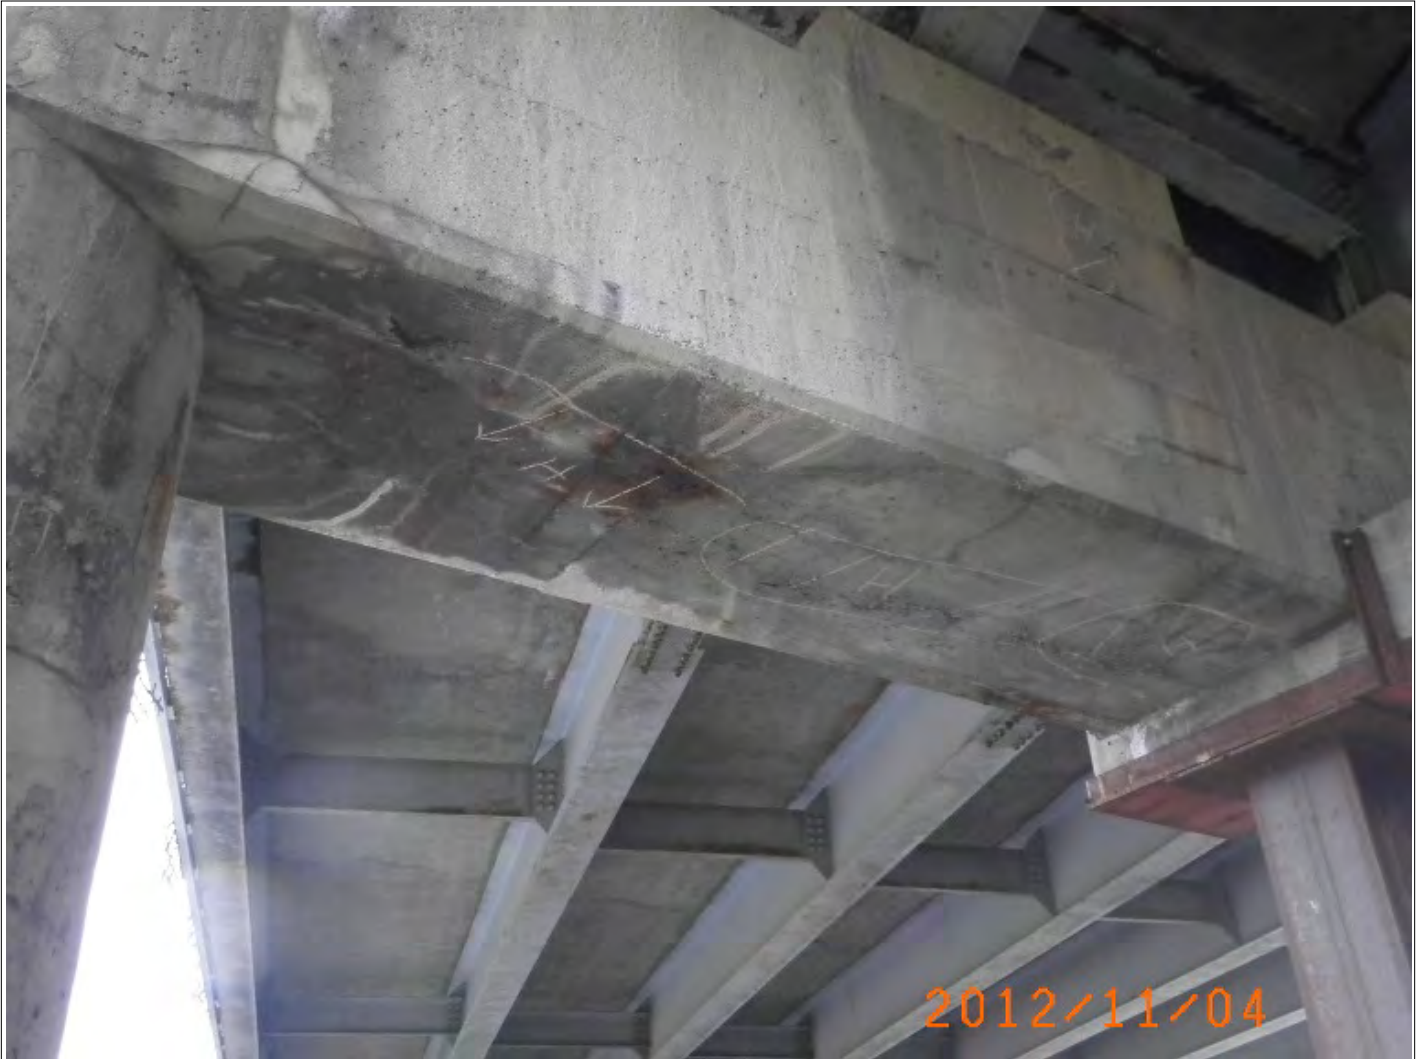
12-2870.JPG - Attached to Yellow Flag 1P120028

Underside of cap - Begin face - between Column 1 and the Bay 1 temp steel column

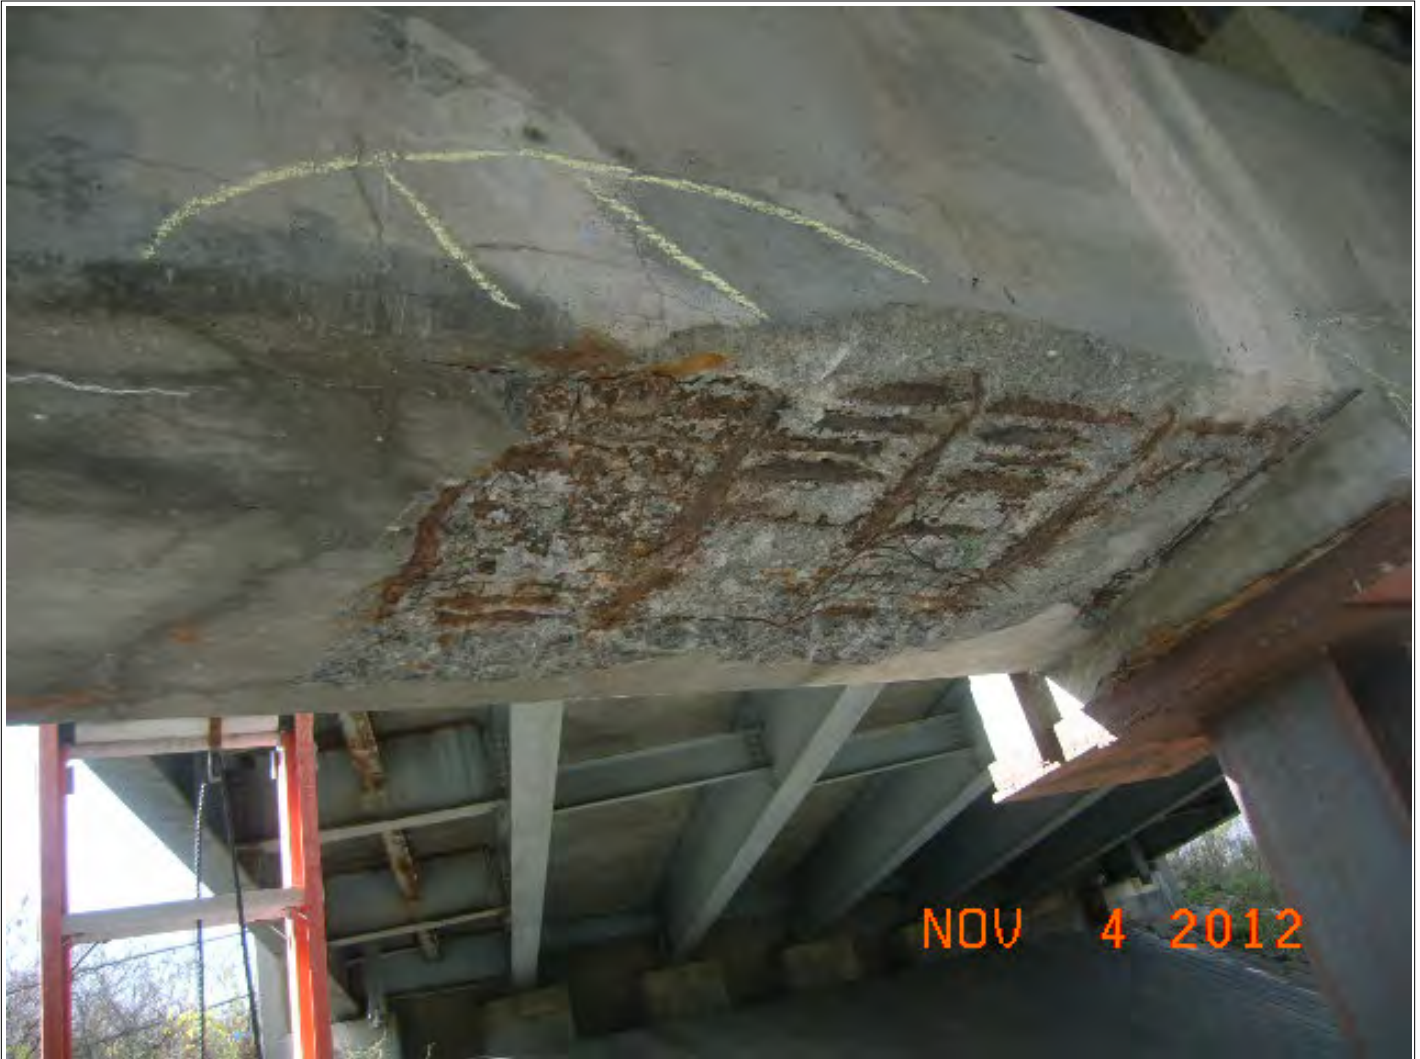
12-6971.JPG - Attached to Yellow Flag 1P120028

Underside of cap - End face - between the Bay 2 temp steel column and Column 3

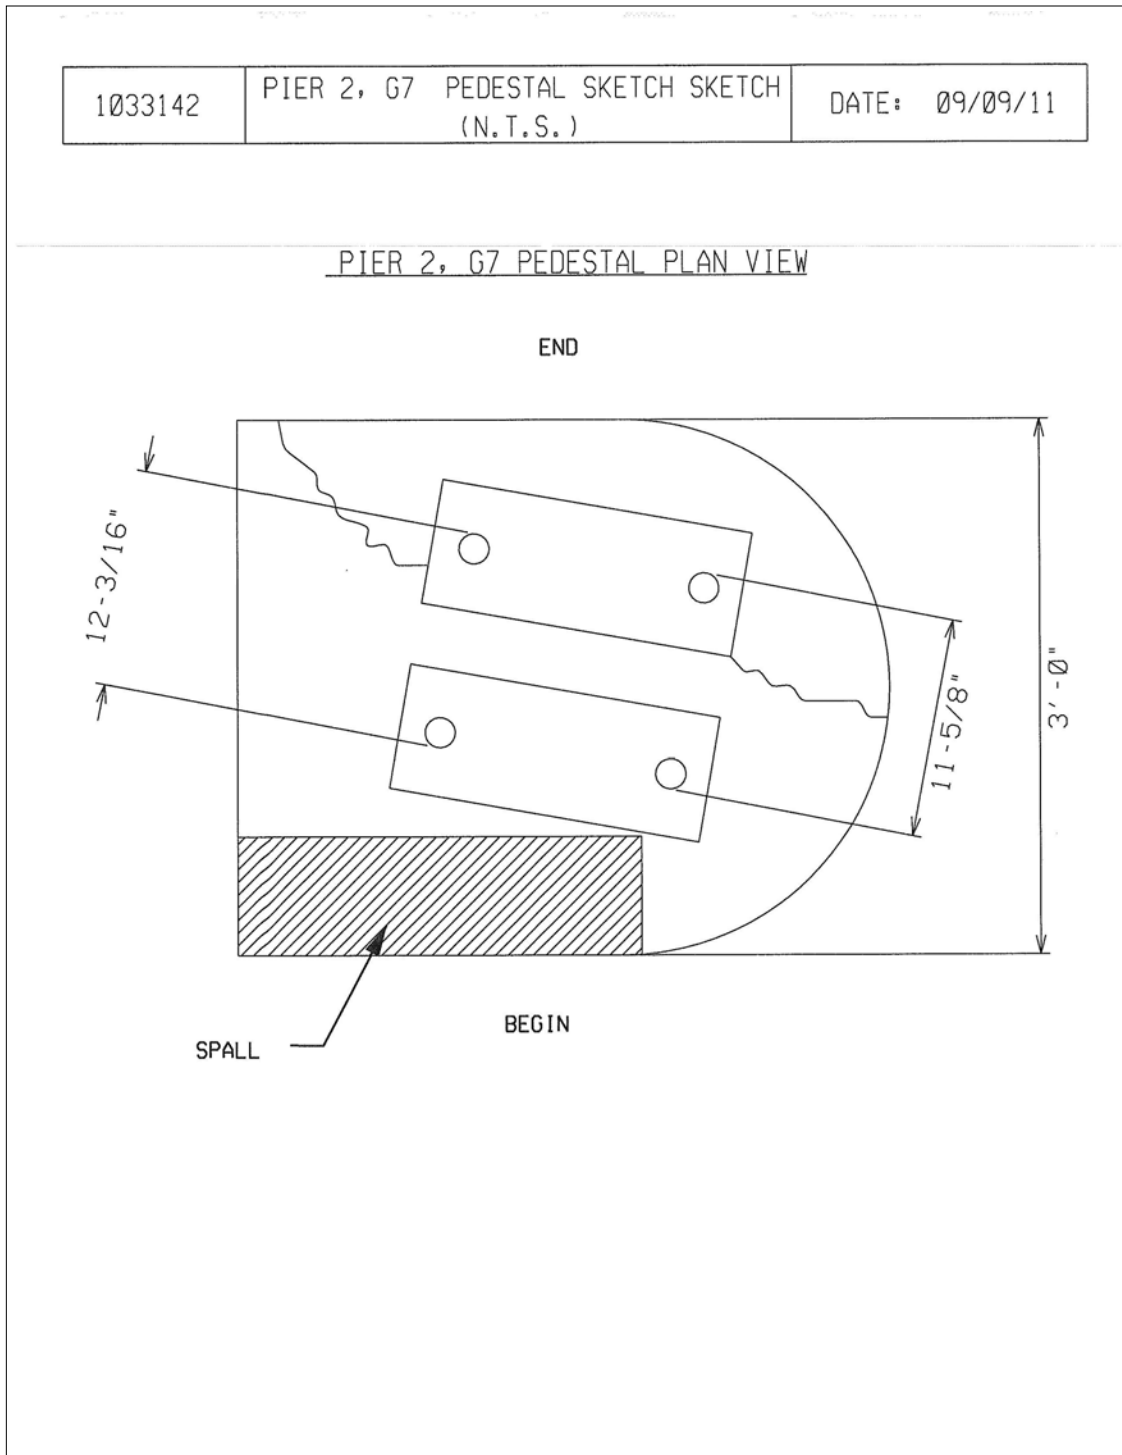
12-P2_Ped7.tif - Attached to RED Flag 1P120031

Monitoring Dimensions - taken 2011 remain the same in 2012
